**Flood Control Project Maintenance
Levee Inspections**

Fall 2019 Levee Maintenance Deficiency Summary Report

Sacramento River Basin

**Flood Control Project Maintenance
Levee Inspections****LMA District Cover Sheet****Fall 2019 Levee Inspection Results****Reclamation District No. 0003 Grand Island**

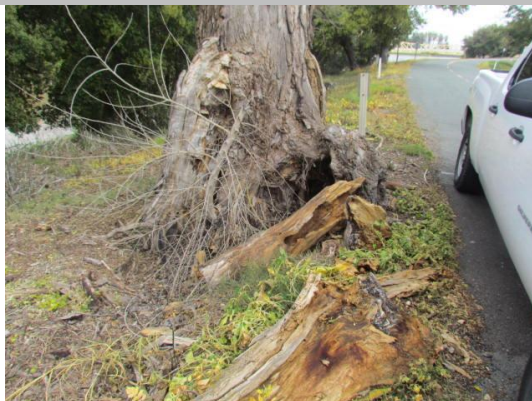
Photo 1 of 3 : FA_2019_RD0003_24_2_20190826_00001.jpg

Looking east at hole at the base of an oak tree on the waterward shoulder. (2016)

LM Start	0.13	Rating **	M	Issue No.	2 (cont)	
LM End	0.13	Issue Type +	Ma	Location *	WS	
Category	Earthen Levee			GPS Latitude/Longitude		
				Start		End
Item	Erosion / Bank Caving			38.303303 °		38.303303 °
				-121.576538 °		-121.576538 °
DWR ID	DWR_RD0003_01_f_2013_2					
Comment Code						
E2 : Schedule repair of erosion site prior to the next inspection.						
Inspector Comment						
A hole (8ft x 2.5ft x 5ft) is next to a large tree on waterward shoulder.

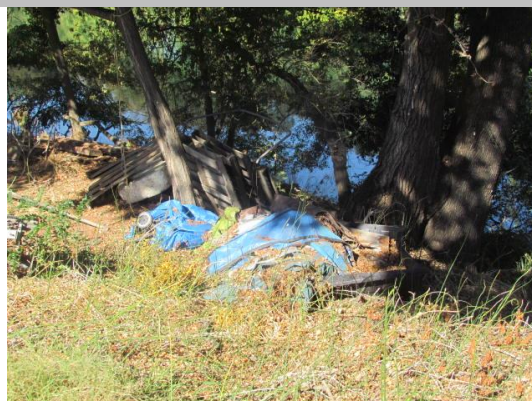
Photo 1 of 4 : FA_2019_RD0003_24_188_20190826_00090.jpg

Looking southwest at garbage on waterward berm. (Fall 2014)

LM Start	0.21	Rating **	M	Issue No.	188 (cont)	
LM End	0.21	Issue Type +	En	Location *	WS	
Category	Earthen Levee			GPS Latitude/Longitude		
				Start		End
Item	Encroachments			38.302625 °		38.302625 °
				-121.577683 °		-121.577683 °
DWR ID	DWR_RD0003_01_s_2012_188					
Comment Code						
GA : Garbage						
Inspector Comment						
Landowner has piled wooden boards and trash on waterside berm.

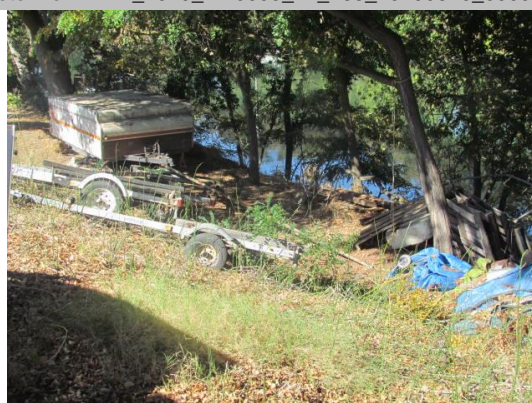
Photo 2 of 4 : FA_2019_RD0003_24_188_20190826_00091.jpg

Looking southwest at garbage and equipment on waterward berm. (Fall 2014)

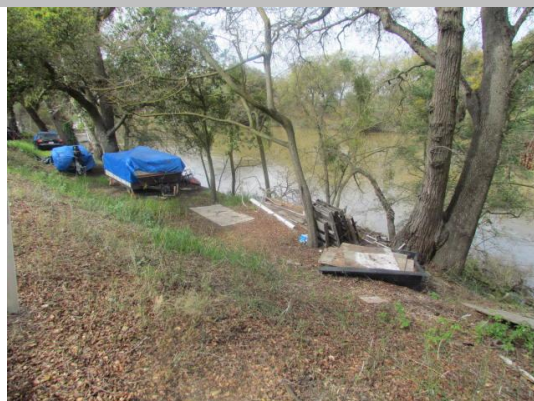
Photo 4 of 4 : FA_2019_RD0003_24_188_20190826_00093.jpg

Looking southwest at trash on waterside berm. (Spring 2014)

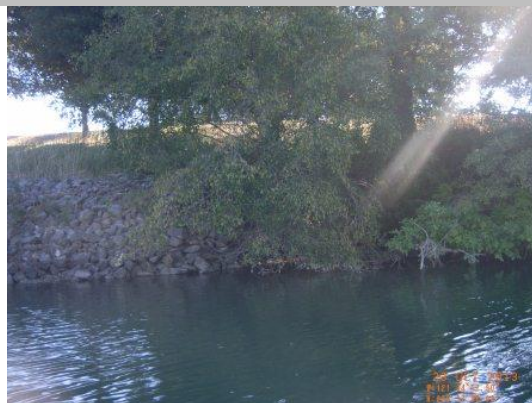
Photo 1 of 1 : FA_2019_RD0003_24_49_20190826_00030.jpg

Site History: 1997 - Erosion of sandy levee on top left bank. Site is downstream of a rock section. Large riparian trees on the bank. 1999 - Upstream half of the reach repaired with rock, except for a 30 ft reach at the upstream end. 2001 - Rock repair on the upstream and downstream ends; no revetment at the trees. 2002 - Rock repair is starting to slide off the geotextile at the upstream end. 2005 - One new small tree has fallen. 2006 - 50 ft pocket at the downstream end and at the upstream end with new rock in between. 2007 - Upstream end has been repaired. 2008 - Area closed sign on bank. Newly fallen trees at both ends and pop outs along the bank. 2010 - Site extended downstream. 2011 - New erosion at the toe. More trees popouts. 2013 - Short vertical sections observed at the downstream end. 2015 - Significant new erosion, large oak tree on verge of popping out. 2016 - Sites 24.8 and 25 were combined.

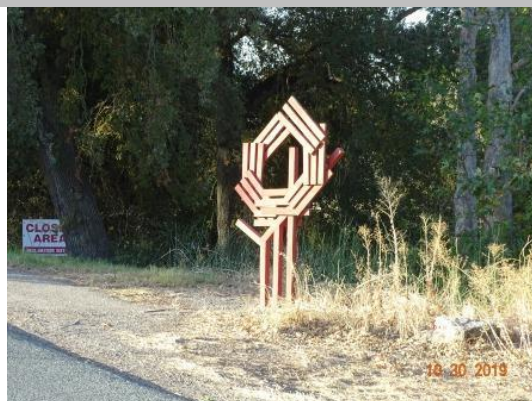
Photo 1 of 1 : FA_2019_RD0003_24_132_20191031_00164.jpg

LM Start	1.04	Rating **	M	Issue No.	132
LM End	1.04	Issue Type +	En	Location *	WS
Category	Earthen Levee			GPS Latitude/Longitude	
				Start	End
Item	Encroachments			38.291528 °	38.291528 °
				-121.582767 °	-121.582767 °
DWR ID	DWR_RD0003_01_f_2014_132				
Comment Code					
SI : Sign					
Inspector Comment					
Unauthorized sign on the waterside shoulder.

View of unauthorized sign on the waterside shoulder (Fall 2019).

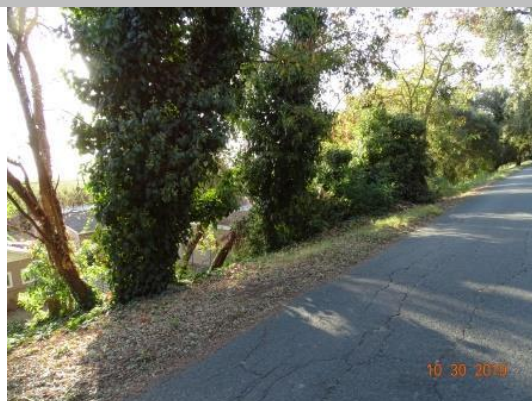
Photo 1 of 1 : FA_2019_RD0003_24_12_20191031_00165.jpg

View looking downstream at landscaping on the landside slope (Fall 2019).

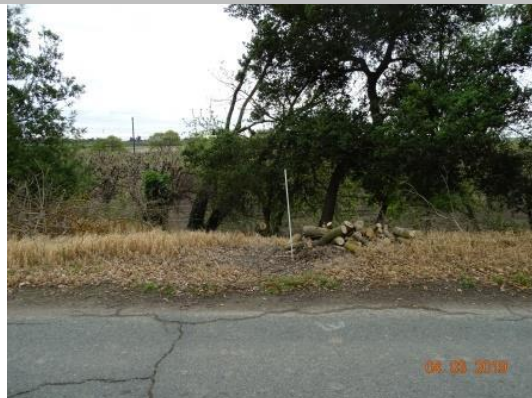
Photo 1 of 1 : FA_2019_RD0003_24_108_20190826_00087.jpg

View of trimmed tree branches on landside shoulder (Spring 2019).

LM Start	1.29	Rating **	M	Issue No.	108
LM End	1.29	Issue Type +	En	Location *	LS
Category	Earthen Levee			GPS Latitude/Longitude	
				Start	End
Item	Encroachments			38.287920 °	38.287920 °
				-121.582822 °	-121.582822 °
DWR ID	DWR_RD0003_01_s_2019_108				
Comment Code					
TR : Tree or limb					
Inspector Comment					
Remove trimmed tree branches from landside slope

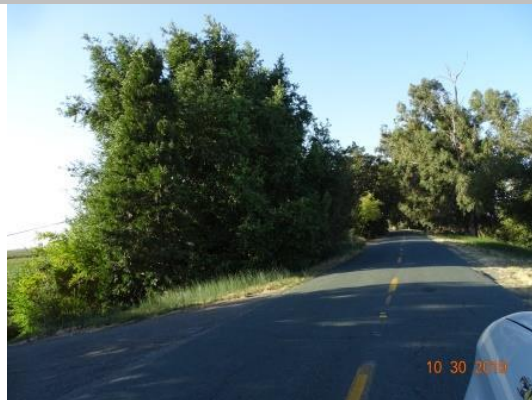
Photo 1 of 1 : FA_2019_RD0003_24_7_20191031_00170.jpg

View looking downstream at landscaping on the landside slope (Fall 2019).

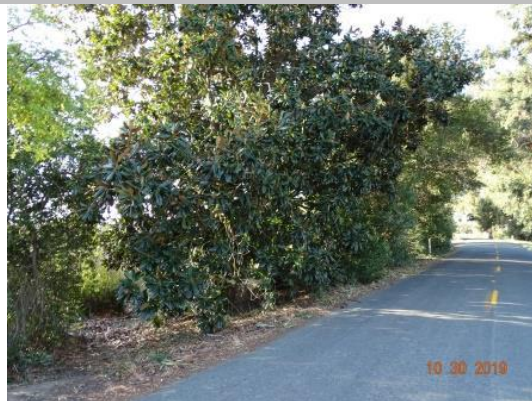
Photo 1 of 1 : FA_2019_RD0003_24_16_20191031_00171.jpg

View looking downstream and landscaping on the landside slope (Fall 2019).

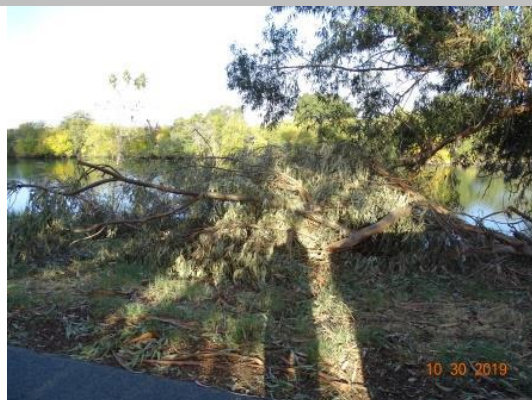
Photo 1 of 1 : FA_2019_RD0003_24_81_20191031_00172.jpg

View of large fallen tree limb on the waterside slope (Fall 2019).

LM Start	1.64	Rating **	U	Issue No.	81
LM End	1.64	Issue Type +	Ma	Location *	WS
Category	Earthen Levee			GPS Latitude/Longitude	
				Start	End
Item	Encroachments			38.284252 °	38.284252 °
				-121.587053 °	-121.587053 °
DWR ID	DWR_RD0003_01_f_2019_81				
Comment Code					
TR : Tree or limb					
Inspector Comment					
Remove the fallen tree limb.

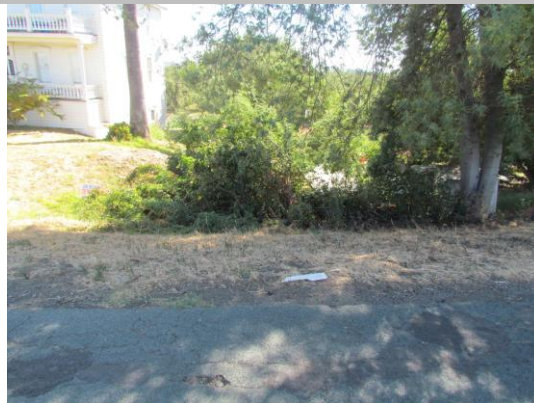
Photo 1 of 2 : FA_2019_RD0003_24_8_20190826_00007.jpg

Looking east at vegetation on landward slope. (Fall 2016)

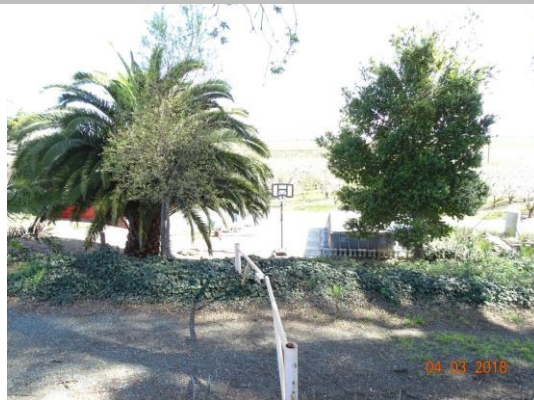
Photo 1 of 1 : FA_2019_RD0003_24_26_20190826_00022.jpg

LM Start	2.38	Rating **	M	Issue No.	26
LM End	2.38	Issue Type +	En	Location *	LS
Category	Earthen Levee			GPS Latitude/Longitude	
				Start	End
Item	Vegetation			38.274775 °	38.274775 °
				-121.588295 °	-121.588295 °
DWR ID	DWR_RD0003_01_s_2013_26				
Comment Code					
V6 : Landscaping					
Inspector Comment					
Landscaping has been reduced in this area, but still inhibits inspection and access.

Landscaping should continue to be reduced.

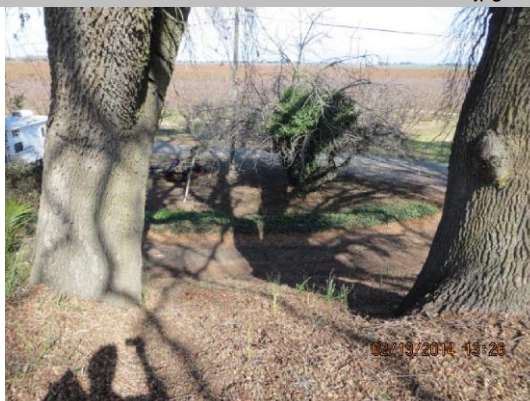
Photo 2 of 3 : UCIP_FA_2019_29569_54640.jpg

Comment Code						
Inspector Comment						
DS_ID:22324 FS_ID:29569 EP_NO: 4346 Repair Type: Non-Urgent Crossing Status: Indicator Found UCIP Comments: Pipe is abandoned and should be verified as having been done so properly. FIELD_STRUCT_DESC: 6-inch steel irrigation discharge pipe through the levee, invert elevation 1.5 feet below the crown. Pump visible at the landside (LS) toe. (Plans for replacing existing 10-inch pipe with a new 10-inch pipe through the levee authorized under Permit No. 4346, 1963 - Hamatani Brothers). [Additional Reference(s): USACE Sacramento O&M Manual 104, February 1960, (RM 23.70)]. FS Date: 2/13/2014

Pump visible at LS toe. Pipe alignment of old pipe goes between two large oaks on LS shoulder.

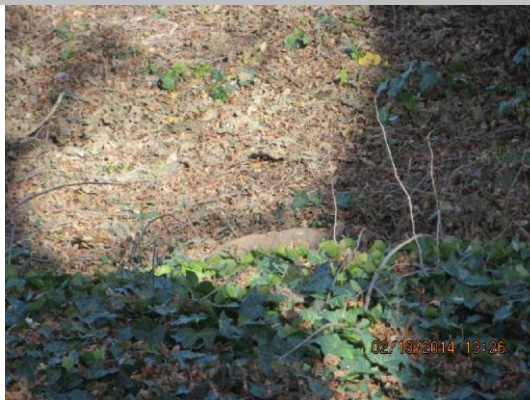
Photo 3 of 3 : UCIP_FA_2019_29569_54639.jpg

Pump visible on LS toe.

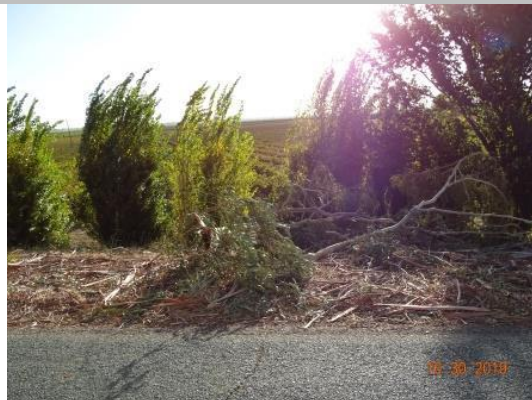
Photo 1 of 1 : FA_2019_RD0003_24_55_20191031_00174.jpg

LM Start	2.58	Rating **	U	Issue No.	55
LM End	2.58	Issue Type +	En	Location *	LS
Category	Earthen Levee			GPS Latitude/Longitude	
				Start	End
Item	Encroachments			38.272187°	38.272187°
				-121.588148°	-121.588148°
DWR ID	DWR_RD0003_01_f_2019_55				
Comment Code					
TR : Tree or limb					
Inspector Comment					
Large fallen tree on the landside slope.

View of fallen tree branches on the landside slope (Fall 2019).

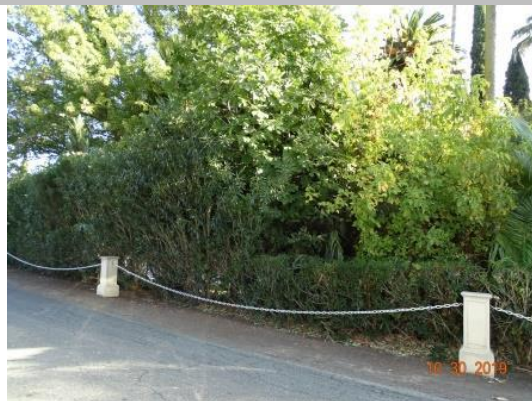
Photo 1 of 1 : FA_2019_RD0003_24_41_20191031_00175.jpg

LM Start	2.82	Rating **	U	Issue No.	41
LM End	2.82	Issue Type +	En	Location *	LS
Category	Earthen Levee			GPS Latitude/Longitude	
				Start	End
Item	Vegetation			38.268844 °	38.268844 °
				-121.588264 °	-121.588264 °
DWR ID	DWR_RD0003_01_s_2012_41				
Comment Code					
V6 : Landscaping					
Inspector Comment

View of landscaping on the landside shoulder (Fall 2019).

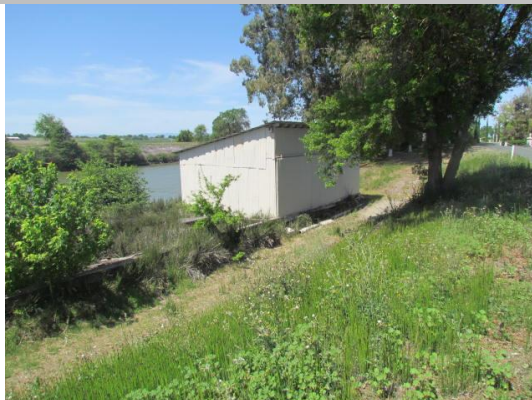
Photo 1 of 1 : FA_2019_RD0003_24_48_20190826_00029.jpg

LM Start	2.87	Rating **	U	Issue No.	48
LM End	2.87	Issue Type +	En	Location *	WS
Category	Earthen Levee			GPS Latitude/Longitude	
				Start	End
Item	Encroachments			38.268257 °	38.268257 °
				-121.587677 °	-121.587677 °
DWR ID	DWR_RD0003_01_s_2013_48				
Comment Code					
BU : Building					
Inspector Comment					
A storage shed has been located here for several years on the waterward berm. The storage shed appears to be abandoned and should be removed.

Looking northwest at storage shed on waterward berm.

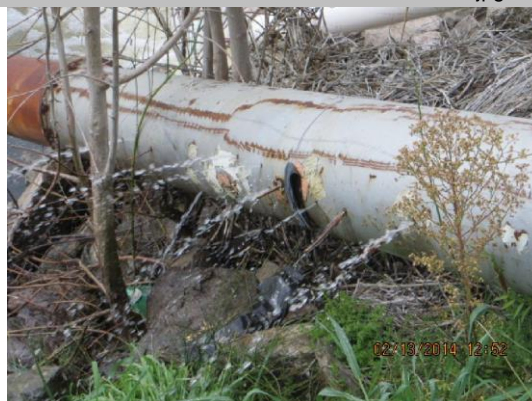
Photo 2 of 3 : UCIP_FA_2019_29563_54621.jpg

Comment Code						
Inspector Comment						
DS_ID:22148 FS_ID:29563 EP_NO: N/A Repair Type: Non-Urgent Crossing Status: Found UCIP Comments: Pitted holes on slant pump intake may indicate internal problem. Good candidate for video inspection. FIELD_STRUCT_DESC: 14-inch steel irrigation discharge pipe though the levee, invert elevation 6.3 feet below the crown. Service pole on the landside (LS) slope. 1.5-inch electrical conduit through the levee to the pump on the waterside (WS). 36-inch concrete standpipe at the landside (LS) toe. [Additional Reference(s): DWR Levee Log, 1993, 16-inch pipe referenced. USACE Sacramento O&M Manual 104, February 1960, (RM 23.17), 16-inch pipe referenced]. FS Date: 2/13/2014

Multiple leaks in suction pipe on WS slope.

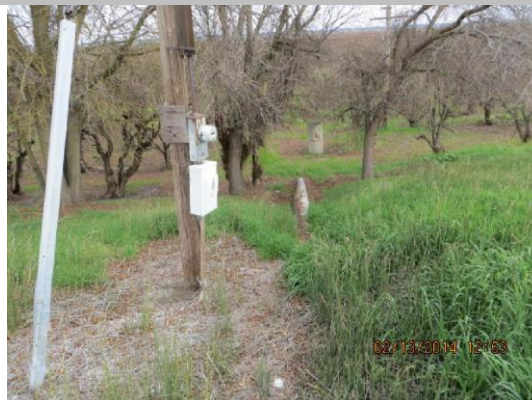
Photo 3 of 3 : UCIP_FA_2019_29563_54620.jpg

Pipe and standpipe visible on LS toe. Power pole and meter on LS slope.

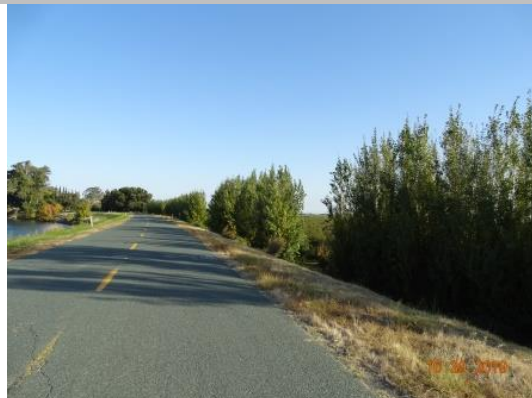
Photo 1 of 1 : FA_2019_RD0003_24_68_20191031_00176.jpg

LM Start	2.93	Rating **	U	Issue No.	68
LM End	3.06	Issue Type +	En	Location *	LS
Category	Earthen Levee			GPS Latitude/Longitude	
				Start	End
Item	Vegetation			38.267448 °	38.265504 °
				-121.587369 °	-121.587155 °
DWR ID	DWR_RD0003_01_s_2018_68				
Comment Code					
V6 : Landscaping					
Inspector Comment					
There is a row of trees along the landside toe which inhibits inspection and prevents access.

View looking upstream at closely spaced trees at the landside toe (Fall 2019).

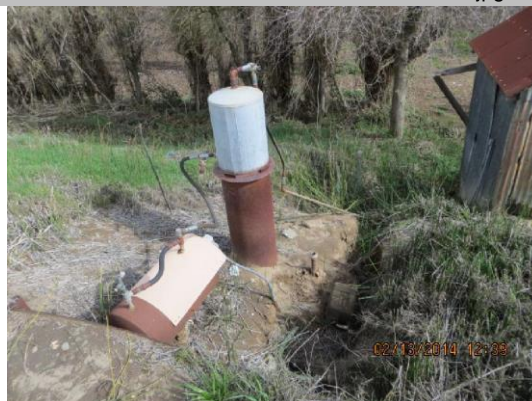
Photo 1 of 2 : UCIP_FA_2019_31327_57380.jpg

Comment Code					
Inspector Comment					
DS_ID:22149 FS_ID:31327 EP_NO: 6870 Repair Type: Non-Urgent Crossing Status: Found UCIP Comments: Erosion on LS slope between pumphouse and tank. FIELD_STRUCT_DESC: 1 of 3: 18-inch steel irrigation discharge pipe through the levee, invert elevation 5.5 feet below the crown. Primer pump in a pump house on the landside (LS) slope. Tank and filler pipes on the LS slope. (Plans to retain a pump house, a pressure tank, two buried metal tanks, and a pipeline authorized under Permit No. 6870, 1970 - H. P. Garin Jr, et al.). [Additional Reference(s): DWR Levee Log, 1993. USACE Sacramento O&M Manual 104, February 1960, (RM 23.03)]. FS Date: 2/13/2014

Pumphouse , tank, and filler pipes visible on LS slope. (note erosion between tank and pumphouse.

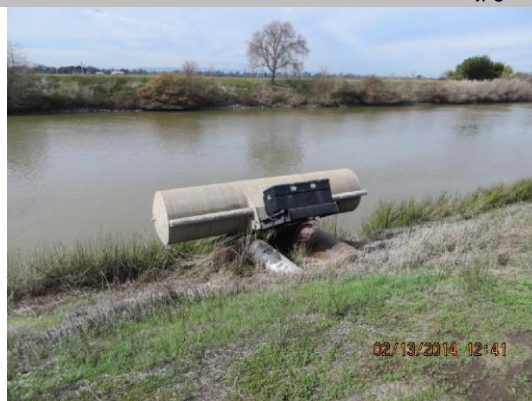
Photo 2 of 2 : UCIP_FA_2019_31327_57379.jpg

Pipe with fish screen visible on WS slope.

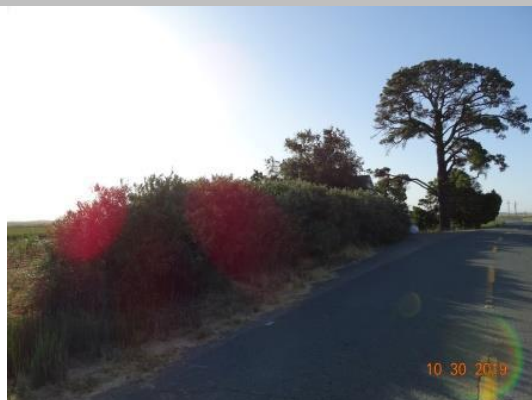
Photo 1 of 1 : FA_2019_RD0003_24_20_20191031_00177.jpg

LM Start	3.11	Rating **	U	Issue No.	20
LM End	3.13	Issue Type +	En	Location *	LS
Category	Earthen Levee			GPS Latitude/Longitude	
				Start	End
Item	Vegetation			38.264902 °	38.264580 °
				-121.587193 °	-121.587220 °
DWR ID	DWR_RD0003_01_s_2012_20				
Comment Code					
V6 : Landscaping					
Inspector Comment

View looking downstream at landscaping on the landside slope (Fall 2019).

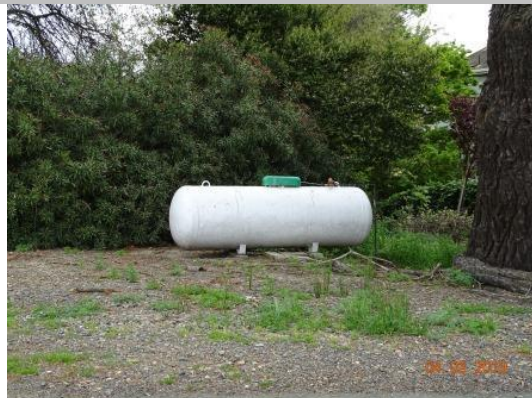
Photo 1 of 1 : FA_2019_RD0003_24_110_20190826_00088.jpg

LM Start	3.12	Rating **	M	Issue No.	110
LM End	3.12	Issue Type +	En	Location *	LS
Category	Earthen Levee			GPS Latitude/Longitude	
				Start	End
Item	Encroachments			38.264688 °	38.264688 °
				-121.587159 °	-121.587159 °
DWR ID	DWR_RD0003_01_s_2019_110				
Comment Code					
TA : Tank					
Inspector Comment					
There is a tank on the landside slope.

View of tank on the landside slope (Spring 2019).

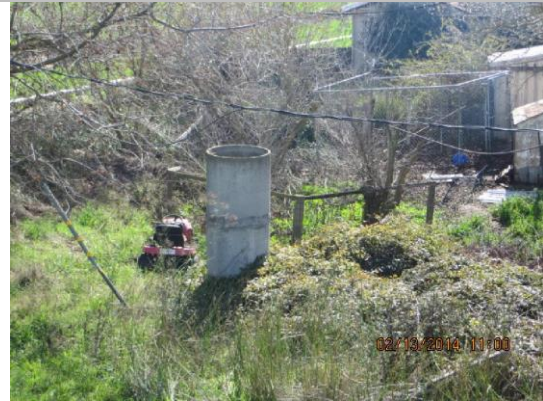
Photo 1 of 2 : UCIP_FA_2019_31583_57841.jpg

Comment Code						
Inspector Comment						
DS_ID:22160 FS_ID:31583 EP_NO: 7948 Repair Type: Non-Urgent Crossing Status: Found UCIP Comments: Siphon breaker missing from LS shoulder. FIELD_STRUCT_DESC: 14-inch coated steel irrigation discharge pipe through the levee, 4.5 feet below the crown. Pipe measures 12 inches on the slopes. Slant pump and platform on the waterside (WS) slope. Siphon breaker on the landside (LS) shoulder. 36-inch concrete standpipe off the LS toe. 1.5-inch galvanized iron electrical conduit at the same location. (Plans to replace pump and pipe through the levee authorized under Permit No. 7948, 1972 - Carl E. van Loben Sels). [Additional Reference(s): DWR Levee Log, 1993. USACE Sacramento O&M Manual 104, February 1960, (RM 21.97), referenced as invert elevation 4.2 feet below the crown]. FS Date: 2/13/2014

36-inch concrete standpipe off LS toe.

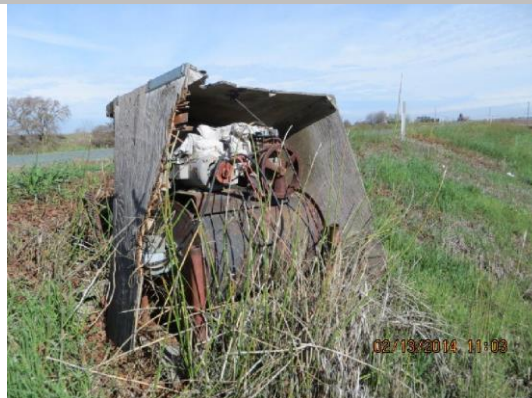
Photo 1 of 3 : UCIP_FA_2019_31584_57843.jpg

Pump and tank in box on LS shoulder.

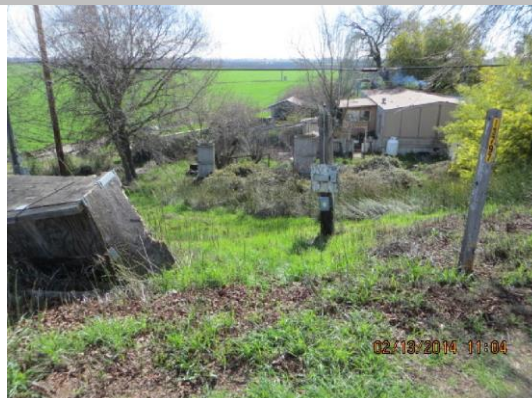
Photo 2 of 3 : UCIP_FA_2019_31584_57842.jpg

Pump and tank in box on LS shoulder with concrete standpipe visible on LS toe.

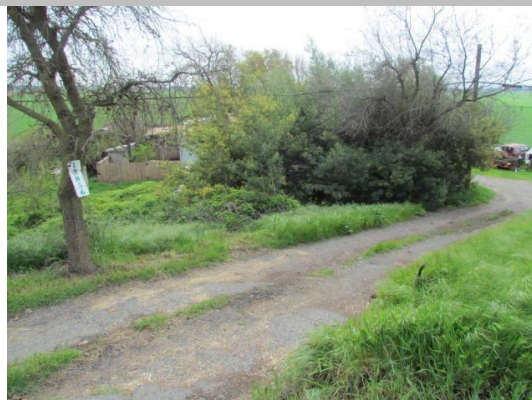
Photo 1 of 1 : FA_2019_RD0003_24_71_20190826_00056.jpg

LM Start	4.12	Rating **	U	Issue No.	71
LM End	4.12	Issue Type +	En	Location *	LS
Category	Earthen Levee			GPS Latitude/Longitude	
				Start	End
Item	Vegetation			38.254565 °	38.254565 °
				-121.596437 °	-121.596437 °
DWR ID	DWR_RD0003_01_f_2017_71				
Comment Code					
V6 : Landscaping					
Inspector Comment					
Dense trees are blocking the view of the landward toe.

Looking east at dense vegetation next to ramp on landward slope.

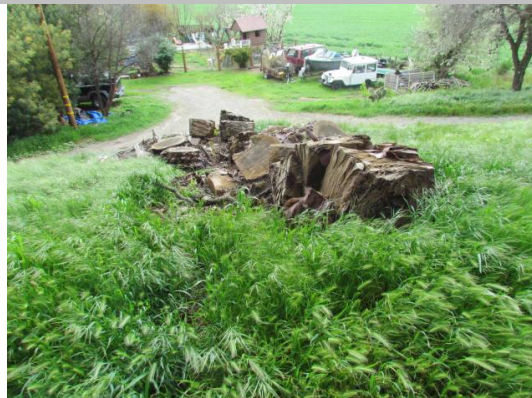
Photo 1 of 1 : FA_2019_RD0003_24_77_20190826_00065.jpg

LM Start	4.13	Rating **	M	Issue No.	77
LM End	4.13	Issue Type +	En	Location *	LS
Category	Earthen Levee			GPS Latitude/Longitude	
				Start	End
Item	Encroachments			38.254443 °	38.254443 °
				-121.596646 °	-121.596646 °
DWR ID	DWR_RD0003_01_s_2016_77				
Comment Code					
MA : Material					
Inspector Comment					
Landowner is storing tree stumps on the landward slope.

Looking east at stumps on landward slope.

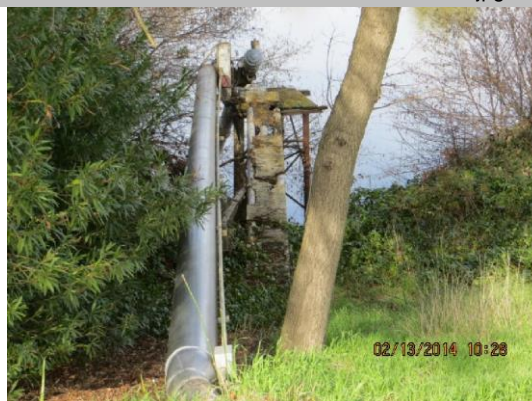
Photo 1 of 3 : UCIP_FA_2019_53483_54546.jpg

DS_ID:22163
FS_ID:53483
EP_NO: N/A
Repair Type: Urgent
Crossing Status: Found
UCIP Comments: 07/20/2018 Everything appears to be the same as last time. No changes have been made. Most of the pipe still remains. Did not see any active leakage. Tape was wrapped around the pipe connections on the LS in 2016 to prevent leaking. Crossing remains "Urgent" due to the pipe integrity issues that have not been fully addressed. (DWR UCIP - A. McDonald)09/29/2017 Received updated photo from DWR levee inspector, D. Torres, and photo shows part or all of the pipe has been removed. Inspector could not verify proper abandonment. Need to coordinate with LMA and owner to determine supporting documentation to support the work completed at this site. This crossing remains urgent due to the details of the extent of the removal. No permit was found to authorizing levee work. (DWR UCIP - O. Magana) 07/06/2016 Pipe diversion off main steam on LS has tape wrapped around its connections, a possible attempt to contain past leakage. Did not see active leakage. Slight sloughing on LS slope at diversion manifold. (DWR UCIP - kfazel)02/13/2014 Pipe disconnected or diverted on LS shoulder and leaking. Water runs down LS slope freely causing erosion. Siphon breaker not visible in CMP riser. Walkway to pump in poor structural condition. (DWR UCIP - pamatya)

Pipe visible on WS slope with slantpump on pier.

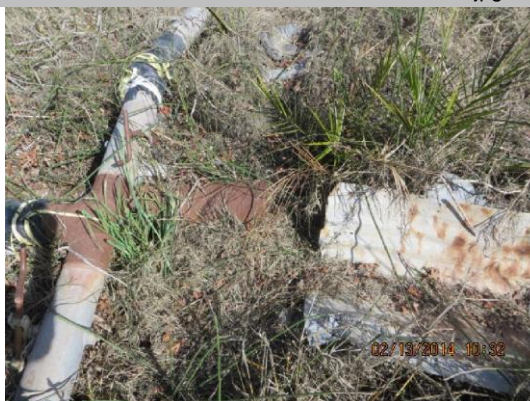
Photo 3 of 3 : UCIP_FA_2019_53483_54544.jpg

UCIP Comments: 07/20/2018 Everything appears to be the same as last time. No changes have been made. Most of the pipe still remains. Did not see any active leakage. Tape was wrapped around the pipe connections on the LS in 2016 to prevent leaking. Crossing remains "Urgent" due to the pipe integrity issues that have not been fully addressed. (DWR UCIP - A. McDonald)09/29/2017 Received updated photo from DWR levee inspector, D. Torres, and photo shows part or all of the pipe has been removed. Inspector could not verify proper abandonment. Need to coordinate with LMA and owner to determine supporting documentation to support the work completed at this site. This crossing remains urgent due to the details of the extent of the removal. No permit was found to authorizing levee work. (DWR UCIP - O. Magana) 07/06/2016 Pipe diversion off main steam on LS has tape wrapped around its connections, a possible attempt to contain past leakage. Did not see active leakage. Slight sloughing on LS slope at diversion manifold. (DWR UCIP - kfazel)02/13/2014 Pipe disconnected or diverted on LS shoulder and leaking. Water runs down LS slope freely causing erosion. Siphon breaker not visible in CMP riser. Walkway to pump in poor structural condition. (DWR UCIP - pamatya)

Pipe diversion manifold just below siphon breaker on LS slope. Tin diverts water downslope.

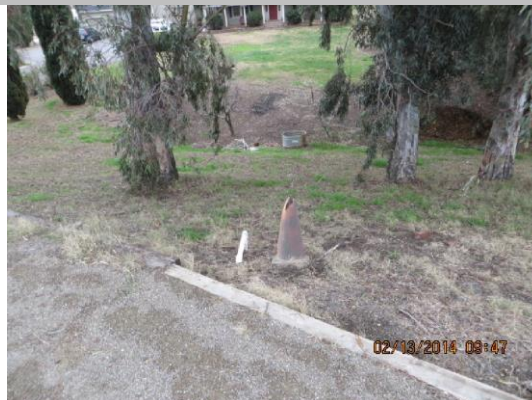
Photo 2 of 3 : UCIP_FA_2019_31286_57294.jpg

Pipe visible on LS shoulder with pump visible at LS toe in background.

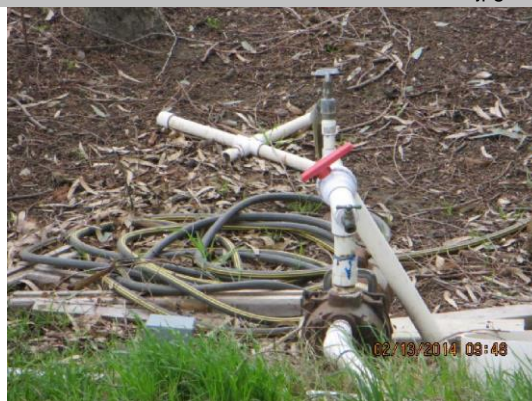
Photo 3 of 3 : UCIP_FA_2019_31286_57293.jpg

LM Start	5.10	Rating **	M	Issue No.	200 (cont)	
LM End	5.10	Issue Type +	En	Location *		
Category	Supplemental			GPS Latitude/Longitude		
				Start	End	
Item	DRAFT DWR UCIP Field Study			38.242649 °	38.242649 °	
				-121.600854 °	-121.600854 °	
DWR ID	24837					
Comment Code						
Inspector Comment						
DS_ID:24837 FS_ID:31286 EP_NO: N/A Repair Type: Non-Urgent Crossing Status: Found UCIP Comments: No permit identified for this crossing. FIELD_STRUCT_DESC: 1.5-inch polyvinyl chloride (PVC) irrigation pipe through the levee, 2 feet below the crown. Pump at the landside (LS) toe. Vent on the waterside (WS) shoulder. This crossing was field discovered. FS Date: 2/13/2014

Pump and shutoff valve visible at LS toe.

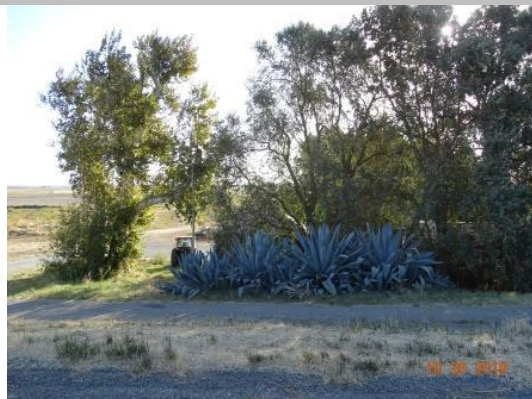
Photo 1 of 1 : FA_2019_RD0003_24_79_20191031_00179.jpg

LM Start	5.25	Rating **	U	Issue No.	79
LM End	5.25	Issue Type +	En	Location *	LS
Category	Earthen Levee			GPS Latitude/Longitude	
				Start	End
Item	Vegetation			38.240420 °	38.240420 °
				-121.601549 °	-121.601549 °
DWR ID	DWR_RD0003_01_f_2018_79				
Comment Code					
V6 : Landscaping					
Inspector Comment					
Large century plants are blocking the view of the landward slope.

View of century plants at the bottom of the landside slope (Fall 2019).

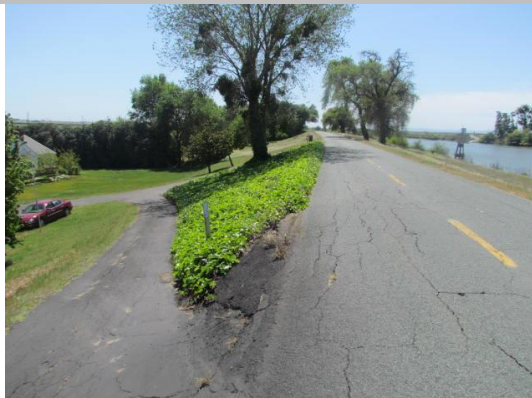
Photo 1 of 1 : FA_2019_RD0003_24_43_20190826_00027.jpg

LM Start	5.33	Rating **	M	Issue No.	43
LM End	5.36	Issue Type +	En	Location *	LS
Category	Earthen Levee			GPS Latitude/Longitude	
				Start	End
Item	Vegetation			38.239276 °	38.238852 °
				-121.601899 °	-121.602000 °
DWR ID	DWR_RD0003_01_s_2012_43				
Comment Code					
V6 : Landscaping					
Inspector Comment

Looking southeast at ground cover on landward slope.

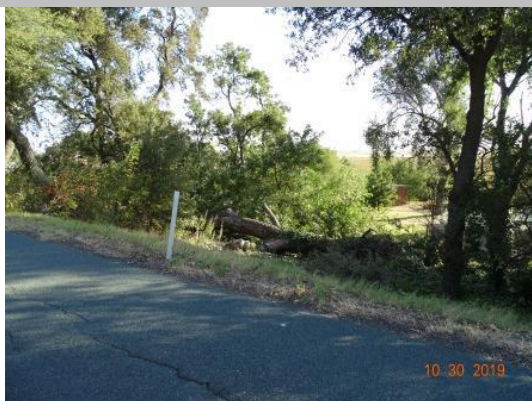
Photo 1 of 1 : FA_2019_RD0003_24_58_20191031_00180.jpg

LM Start	5.46	Rating **	U	Issue No.	58
LM End	5.46	Issue Type +	En	Location *	LS
Category	Earthen Levee			GPS Latitude/Longitude	
				Start	End
Item	Encroachments			38.237515 °	38.237515 °
				-121.602225 °	-121.602225 °
DWR ID	DWR_RD0003_01_s_2017_58				
Comment Code					
TR : Tree or limb					
Inspector Comment					
A downed tree with large root ball on the landward slope is being cut up and should be removed.

View looking upstream at down tree on the landside slope (Fall 2019).

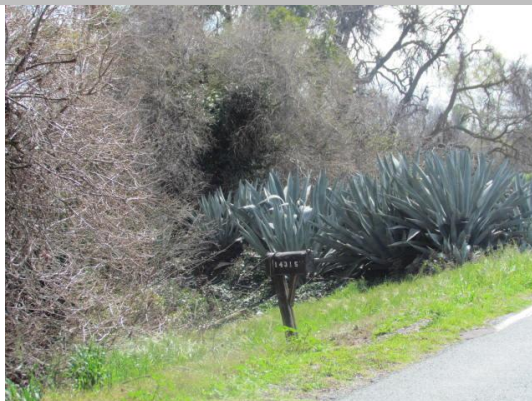
Photo 1 of 1 : FA_2019_RD0003_24_44_20190826_00028.jpg

LM Start	5.49	Rating **	U	Issue No.	44
LM End	5.49	Issue Type +	En	Location *	LS
Category	Earthen Levee			GPS Latitude/Longitude	
				Start	End
Item	Vegetation			38.236994 °	38.236994 °
				-121.602278 °	-121.602278 °
DWR ID	DWR_RD0003_01_s_2012_44				
Comment Code					
V6 : Landscaping					
Inspector Comment					
Large century plants are located on the landside slope.

Looking southeast at century plants on landside shoulder and slope.

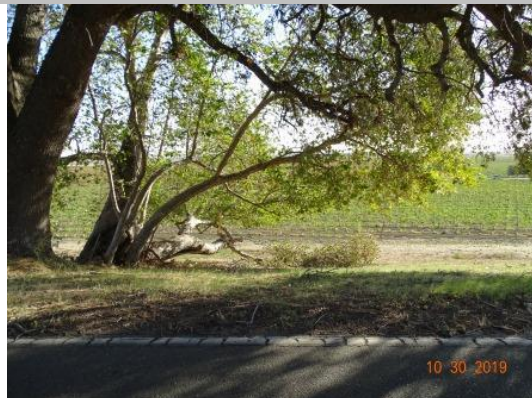
Photo 1 of 1 : FA_2019_RD0003_24_63_20191031_00181.jpg

LM Start	5.65	Rating **	M	Issue No.	63
LM End	5.65	Issue Type +	Ma	Location *	LS
Category	Earthen Levee			GPS Latitude/Longitude	
				Start	End
Item	Trim / Thin Trees			38.234721°	38.234721°
				-121.601709°	-121.601709°
DWR ID	DWR_RD0003_01_f_2016_63				
Comment Code					
T1 : Trim trees to at least five feet above ground level.					
Inspector Comment					
A tree limb is dangling from tree.

View of down limb on the landside slope (Fall 2019).

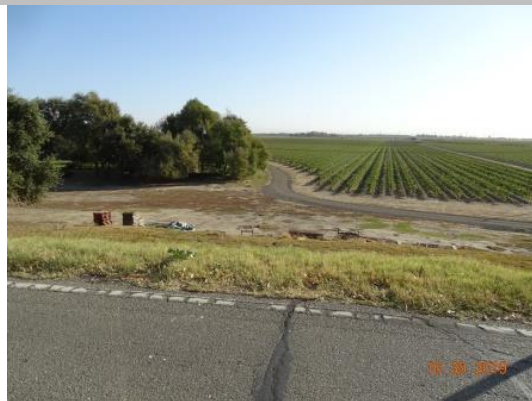
Photo 1 of 1 : FA_2019_RD0003_24_87_20191031_00182.jpg

LM Start	5.78	Rating **	M	Issue No.	87
LM End	5.78	Issue Type +	En	Location *	LS
Category	Earthen Levee			GPS Latitude/Longitude	
				Start	End
Item	Encroachments			38.232878 °	38.232878 °
				-121.601277 °	-121.601277 °
DWR ID	DWR_RD0003_01_f_2019_87				
Comment Code					
EQ : Equipment					
Inspector Comment

View of farming material at the landside toe (Fall 2019).

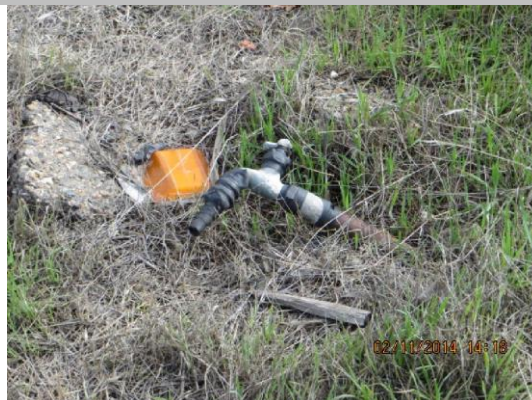
Photo 2 of 3 : UCIP_FA_2019_29823_55104.jpg

Vent on LS shoulder.

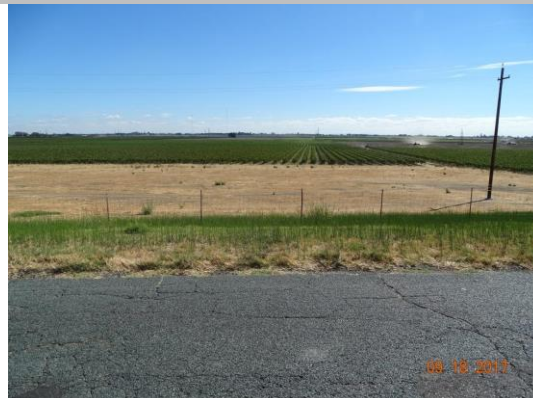
Photo 1 of 1 : FA_2019_RD0003_24_84_20190826_00073.jpg

LM Start	6.32	Rating **	M	Issue No.	84
LM End	6.62	Issue Type +	En	Location *	LS
Category	Earthen Levee			GPS Latitude/Longitude	
				Start	End
Item	Encroachments			38.225176 °	38.220769 °
				-121.601329 °	-121.601105 °
DWR ID	DWR_RD0003_01_f_2017_84				
Comment Code					
FE : Fence					
Inspector Comment					
There is a fence on the landside slope.

Looking east at fence at landside toe.

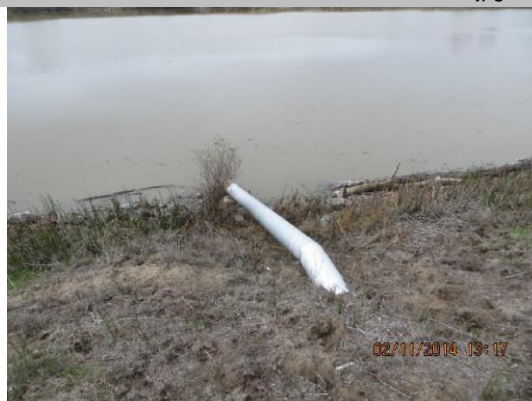
Photo 1 of 3 : UCIP_FA_2019_29258_54138.jpg

Comment Code					
Inspector Comment					
DS_ID:22179 FS_ID:29258 EP_NO: 853 Repair Type: Non-Urgent Crossing Status: Found UCIP Comments: Siphon breaker/vent needs proper installation/riser. FIELD_STRUCT_DESC: 12-inch steel irrigation siphon through the levee, invert elevation 4 feet below the crown. Siphon breaker on the landside (LS) shoulder. 36-inch concrete standpipe on the LS toe. (Plans for the installation of a 6-inch horizontal bolted centrifugal pump together with an 8-inch, 10-gauge welded steel pipe through the levee authorized under Permit No. 853, 1941 - Louis A. Bixler. Plans for installing a 12-inch steel irrigation siphon through the levee authorized under Permit No. 1462, 1950 - Vic Romanini. USACE Unit No. 10, new pipe installed in 1967). [Additional Reference(s): DWR Levee Log, 1993. USACE Sacramento O&M Manual 104, February 1960, (RM 19.20)]. FS Date: 2/11/2014

Pipe visible on WS slope.

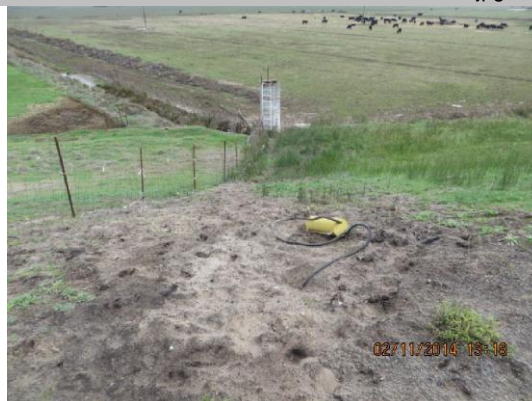
Photo 2 of 3 : UCIP_FA_2019_29258_54137.jpg

Siphon breaker/vent visible on LS slope with concrete standpipe visible in background at toe.

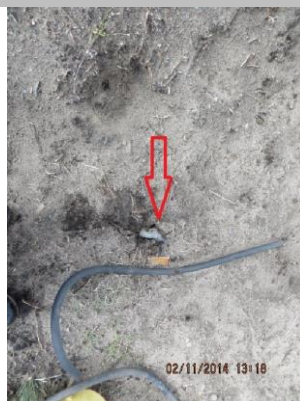
Photo 3 of 3 : UCIP_FA_2019_29258_54136.jpg

Comment Code						
Inspector Comment						
DS_ID:22179 FS_ID:29258 EP_NO: 853 Repair Type: Non-Urgent Crossing Status: Found UCIP Comments: Siphon breaker/vent needs proper installation/riser. FIELD_STRUCT_DESC: 12-inch steel irrigation siphon through the levee, invert elevation 4 feet below the crown. Siphon breaker on the landside (LS) shoulder. 36-inch concrete standpipe on the LS toe. (Plans for the installation of a 6-inch horizontal bolted centrifugal pump together with an 8-inch, 10-gauge welded steel pipe through the levee authorized under Permit No. 853, 1941 - Louis A. Bixler. Plans for installing a 12-inch steel irrigation siphon through the levee authorized under Permit No. 1462, 1950 - Vic Romanini. USACE Unit No. 10, new pipe installed in 1967). [Additional Reference(s): DWR Levee Log, 1993. USACE Sacramento O&M Manual 104, February 1960, (RM 19.20)]. FS Date: 2/11/2014

Siphon breaker/vent visible on LS slope.

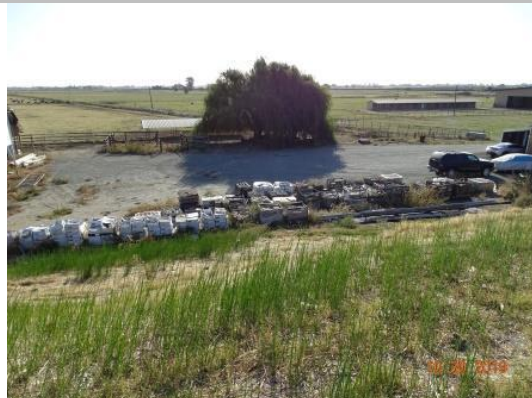
Photo 1 of 1 : FA_2019_RD0003_24_88_20191031_00183.jpg

LM Start	6.95	Rating **	M	Issue No.	88
LM End	6.95	Issue Type +	En	Location *	LS
Category	Earthen Levee			GPS Latitude/Longitude	
				Start	End
Item	Encroachments			38.216588 °	38.216588 °
				-121.603970 °	-121.603970 °
DWR ID	DWR_RD0003_01_f_2019_88				
Comment Code					
EQ : Equipment					
Inspector Comment					
Equipment within 10 feet of levee toe

View of farming equipment at the landside toe (Fall 2019).

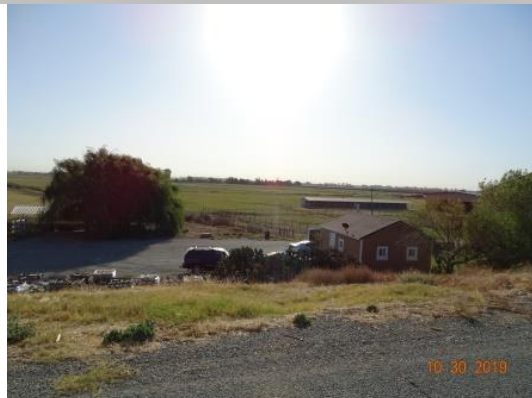
Photo 1 of 1 : FA_2019_RD0003_24_93_20191031_00184.jpg

LM Start	6.96	Rating **	U	Issue No.	93
LM End	6.96	Issue Type +	En	Location *	LS
Category	Earthen Levee			GPS Latitude/Longitude	
				Start	End
Item	Vegetation			38.216467°	38.216467°
				-121.604050°	-121.604050°
DWR ID	DWR_RD0003_01_f_2019_93				
Comment Code					
V6 : Landscaping					
Inspector Comment					
Cactus at landside toe

View of large cactus at the landside toe (Fall 2019).

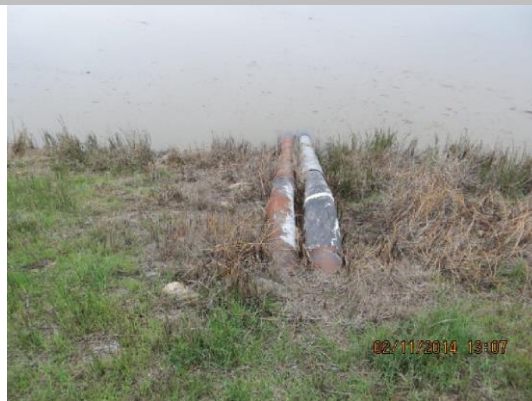
Photo 1 of 3 : UCIP_FA_2019_50428_54124.jpg

Comment Code					
Inspector Comment					
DS_ID:22346 FS_ID:50428 EP_NO: N/A Repair Type: Non-Urgent Crossing Status: Found UCIP Comments: 07/06/2016 Same as last inspection. Annular space needs to be grouted per Title 23. This crossing has been downgraded from Urgent to Non-Urgent because the hole created in the conduit sleeve was deliberate and not a sign of pipe failure. Pipe was flowing at the time of the inspection (possibly via a portable pump). (DWR UCIP - K. Fazel)02/11/2014 Pipe cut open on LS shoulder and along slope. 3.5-inch PVC pipe sleeved through with 2 vents with valves. Pipe annular space not grouted. (DWR FPIIB - G. Wylie) FIELD_STRUCT_DESC: 1 of 2: 12-inch steel irrigation siphon through the levee, invert elevation 3 feet below the crown. Siphon breaker on the landside (LS) shoulder. 3.5-inch polyvinyl chloride (PVC) pipe sleeved through the existing 12-inch pipe. (Vic Romanini). [Additional Reference(s): DWR Levee Log, 1993. USACE Sacramento O&M Manual 104, February 1960, (RM 19.06)]. FS Date: 7/6/2016

Steel pipe visible on WS slope

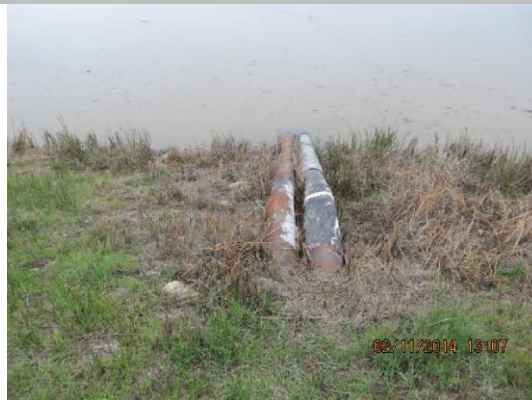
Photo 1 of 3 : UCIP_FA_2019_50427_54133.jpg

DS_ID:22180
FS_ID:50427
EP_NO: N/A
Repair Type: Non-Urgent
Crossing Status: Found
UCIP Comments: 07/06/2016 Same as last inspection. Annular space needs to be grouted per Title 23. This crossing has been downgraded from Urgent to Non-Urgent because the deformed nature of the pipe is not indicative of imminent failure. (DWR UCIP - K. Fazel)02/11/2014 Pipe sleeved with a PVC pipe that is crushed on the WS slope. Annular space not grouted. (DWR FPIIB - G. Wylie)
FIELD_STRUCT_DESC: 2 of 2: 14-inch steel irrigation siphon through the levee, invert elevation 3.1 feet below the crown. Siphon breaker on the landside (LS) shoulder. 14-inch pipe sleeved with a smaller diameter polyvinyl chloride (PVC) pipe. (Vic Romanini). [Additional Reference(s): DWR Levee Log, 1993, referenced as 3 feet below the crown. USACE Sacramento O&M Manual 104, February 1960, (RM 19.06)].
FS Date: 7/6/2016

Pipe visible on WS slope, PVC pipe exposed and crushed on WS slope.

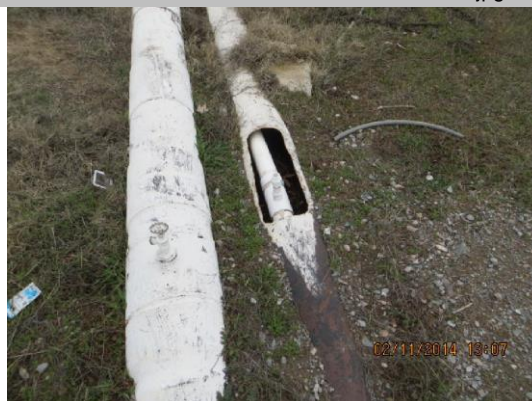
Photo 3 of 3 : UCIP_FA_2019_50427_54131.jpg

Comment Code						
Inspector Comment						
DS_ID:22180 FS_ID:50427 EP_NO: N/A Repair Type: Non-Urgent Crossing Status: Found UCIP Comments: 07/06/2016 Same as last inspection. Annular space needs to be grouted per Title 23. This crossing has been downgraded from Urgent to Non-Urgent because the deformed nature of the pipe is not indicative of imminent failure. (DWR UCIP - K. Fazel)02/11/2014 Pipe sleeved with a PVC pipe that is crushed on the WS slope. Annular space not grouted. (DWR FPIIB - G. Wylie) FIELD_STRUCT_DESC: 2 of 2: 14-inch steel irrigation siphon through the levee, invert elevation 3.1 feet below the crown. Siphon breaker on the landside (LS) shoulder. 14-inch pipe sleeved with a smaller diameter polyvinyl chloride (PVC) pipe. (Vic Romanini). [Additional Reference(s): DWR Levee Log, 1993, referenced as 3 feet below the crown. USACE Sacramento O&M Manual 104, February 1960, (RM 19.06)]. FS Date: 7/6/2016

Siphon breaker on PVC pipe on LS slope.

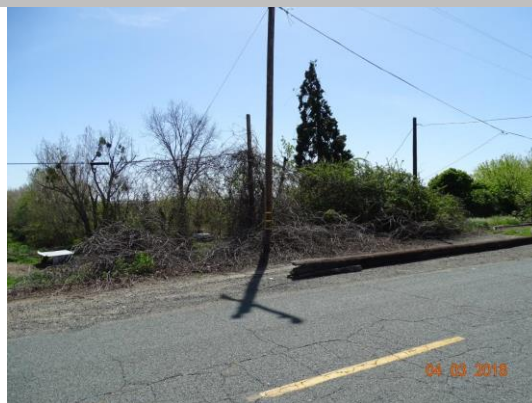
Photo 1 of 1 : FA_2019_RD0003_24_90_20190826_00075.jpg

LM Start	7.61	Rating **	U	Issue No.	90
LM End	7.63	Issue Type +	En	Location *	LS
Category	Earthen Levee			GPS Latitude/Longitude	
				Start	End
Item	Vegetation			38.208017 °	38.207700 °
				-121.609185 °	-121.609342 °
DWR ID	DWR_RD0003_01_s_2018_90				
Comment Code					
V6 : Landscaping					
Inspector Comment					
Landside landscaping inhibits the inspection and access.

View of landscaping on the landside slope.

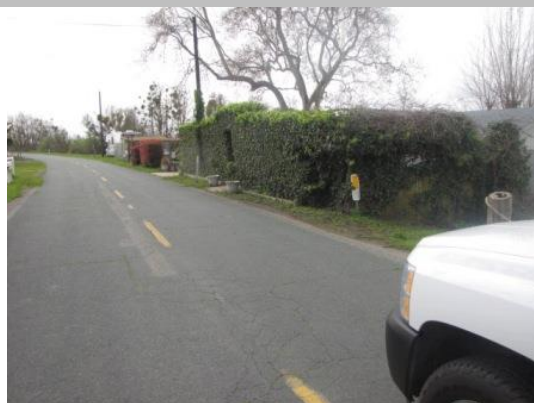
Photo 1 of 1 : FA_2019_RD0003_24_75_20190826_00064.jpg

LM Start	7.64	Rating **	U	Issue No.	75
LM End	7.64	Issue Type +	En	Location *	WS
Category	Earthen Levee			GPS Latitude/Longitude	
				Start	End
Item	Vegetation			38.207640 °	38.207640 °
				-121.609334 °	-121.609334 °
DWR ID	DWR_RD0003_01_s_2012_75				
Comment Code					
V6 : Landscaping					
Inspector Comment

Looking southwest at landscaping in front of a house on waterside berm.
Also not in the picture a building on landside berm.

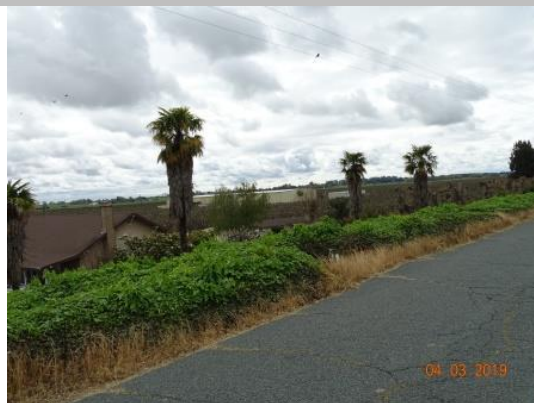
Photo 1 of 1 : FA_2019_RD0003_24_91_20190826_00076.jpg

LM Start	7.74	Rating **	M	Issue No.	91
LM End	7.76	Issue Type +	En	Location *	LS
Category	Earthen Levee			GPS Latitude/Longitude	
				Start	End
Item	Vegetation			38.206207°	38.205813°
				-121.609606°	-121.609607°
DWR ID	DWR_RD0003_01_s_2018_91				
Comment Code					
V6 : Landscaping					
Inspector Comment

View looking downstream at landscape vegetation on the landside slope
(Spring 2019).

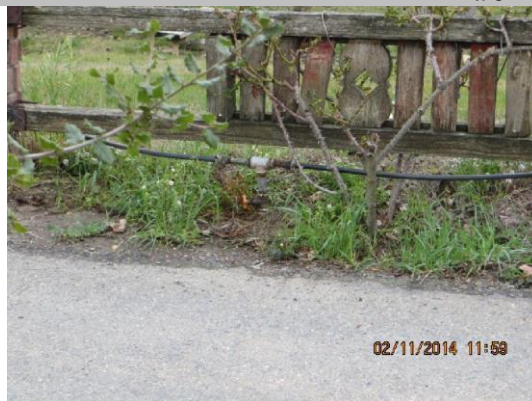
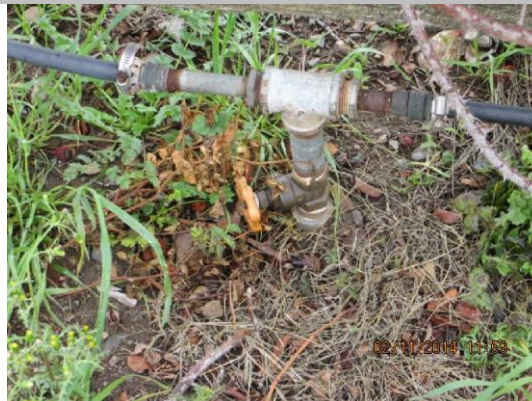
LM Start	7.76	Rating **	M	Issue No.	208
LM End	7.76	Issue Type +	En	Location *	
Category	Supplemental			GPS Latitude/Longitude	
				Start	End
Item	DRAFT DWR UCIP Field Study			38.205846 °	38.205846 °
				-121.609574 °	-121.609574 °
DWR ID	24836				
Comment Code					
Inspector Comment					
DS_ID:24836 FS_ID:31283 EP_NO: N/A Repair Type: Non-Urgent Crossing Status: Found UCIP Comments: No permit identified for this crossing. FIELD_STRUCT_DESC: 2.5-inch galvanized iron irrigation pipe through the levee, at an unknown depth. Pipe and spigot visible at the waterside (WS) toe. A second spigot on the landside (LS) slope. This crossing was field discovered. FS Date: 2/11/2014

Shutoff valve next to LS ramp

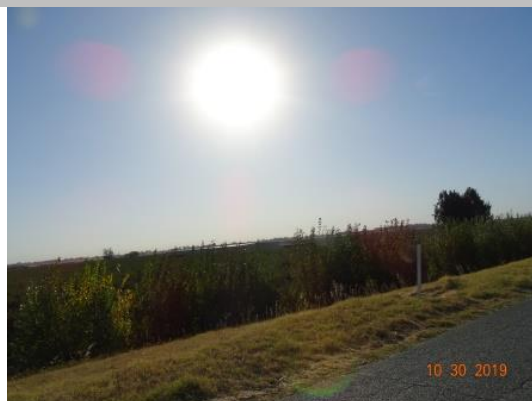
Photo 1 of 1 : FA_2019_RD0003_24_78_20191031_00185.jpg

LM Start	7.80	Rating **	U	Issue No.	78
LM End	8.25	Issue Type +	En	Location *	LS
Category	Earthen Levee			GPS Latitude/Longitude	
				Start	End
Item	Vegetation			38.205243 °	38.198989 °
				-121.609689 °	-121.611815 °
DWR ID	DWR_RD0003_01_s_2012_78				
Comment Code					
V6 : Landscaping					
Inspector Comment					
Trees are within 10 feet of the levee toe and obstruct access and visibility of the levee toe.

View looking downstream at closely spaced trees at the landside toe (Fall 2019).

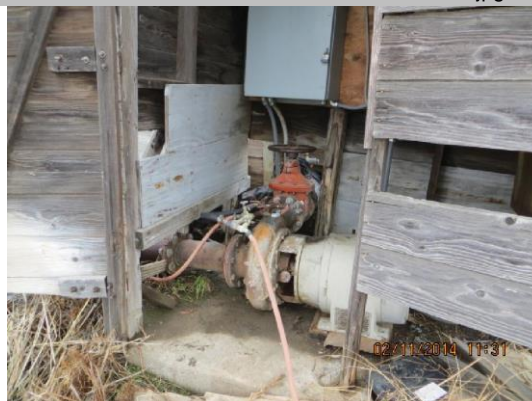
Photo 2 of 3 : UCIP_FA_2019_29235_54052.jpg

Comment Code						
Inspector Comment						
DS_ID:22186 FS_ID:29235 EP_NO: 2225 Repair Type: Non-Urgent Crossing Status: Found UCIP Comments: CMP riser knocked over and no sign of siphon breaker. FIELD_STRUCT_DESC: 8-inch steel irrigation discharge pipe through the levee, invert elevation 3.5 feet below the crown. Service pole and siphon breaker in a corrugated metal pipe (CMP) riser on the landside (LS) slope. Pump in a pump house and a booster pump on a concrete slab on the waterside (WS) slope. (Plans to install an 8-inch irrigation pipe through the levee and an inclined pump on the WS slope authorized under Permit No. 2225, 1955 - Fay Ranch, Captain N. A. Fay, care of The River Lines, Inc. USACE Unit No. 10, new pipe installed in 1967). [Additional Reference(s): DWR Levee Log, 1993. USACE Sacramento O&M Manual 104, February 1960, (17.92)]. FS Date: 2/11/2014

Pump and gate valve visible inside pumphouse on WS shoulder.

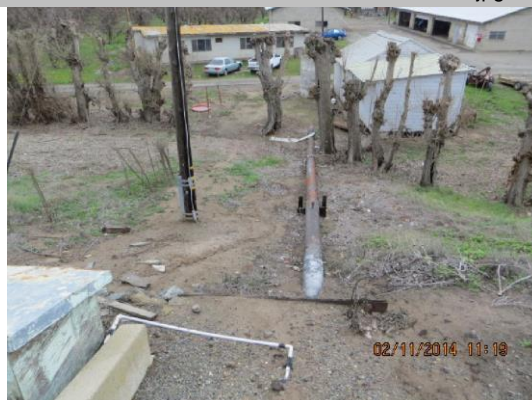
Photo 2 of 3 : UCIP_FA_2019_29233_54046.jpg

Pipe, pumphouse, and standpipe visible on LS slope.

Comment Code						
Inspector Comment						
DS_ID:22187						
FS_ID:29233						
EP_NO: N/A						
Repair Type: Non-Urgent						
Crossing Status: Found						
UCIP Comments: Siphon breaker and CMP riser missing from LS slope.						
FIELD_STRUCT_DESC: 12-inch steel irrigation siphon through the						
levee, invert elevation 3.5 feet below the crown. Primer pump in a pump						
house and a siphon breaker in a corrugated metal pipe (CMP) riser on						
the landside (LS) slope. 48-inch concrete standpipe at the LS toe.						
(USACE Unit No. 10, new pipe installed in 1967). [Additional						
Reference(s): DWR Levee Log, 1993. USACE Sacramento O&M						
Manual 104, February 1960, (RM 17.79)].						
FS Date: 2/11/2014

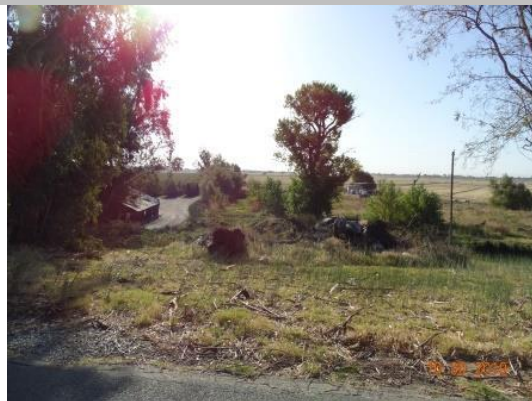
Photo 1 of 1 : FA_2019_RD0003_24_59_20191031_00186.jpg

LM Start	8.88	Rating **	M	Issue No.	59
LM End	8.88	Issue Type +	En	Location *	LS
Category	Earthen Levee			GPS Latitude/Longitude	
				Start	End
Item	Encroachments			38.193217 °	38.193217 °
				-121.620050 °	-121.620050 °
DWR ID	DWR_RD0003_01_s_2017_59				
Comment Code					
PR : Prunings					
Inspector Comment					
Pruning pile on the landward slope needs to be removed.

View of pruning pile on the landside slope (Fall 2019).

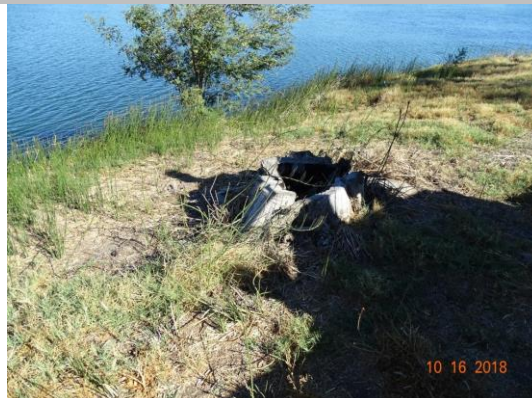
Photo 1 of 1 : FA_2019_RD0003_24_39_20190826_00026.jpg

LM Start	8.92	Rating **	U	Issue No.	39
LM End	8.92	Issue Type +	Ma	Location *	WS
Category	Earthen Levee			GPS Latitude/Longitude	
				Start	End
Item	Trim / Thin Trees			38.193000 °	38.193000 °
				-121.620700 °	-121.620700 °
DWR ID	DWR_RD0003_01_f_2018_39				
Comment Code					
T5 : Tree stumps.					
Inspector Comment					
Remove the rotting tree stump.

View of rotting tree stump on water side crown (October 2018).

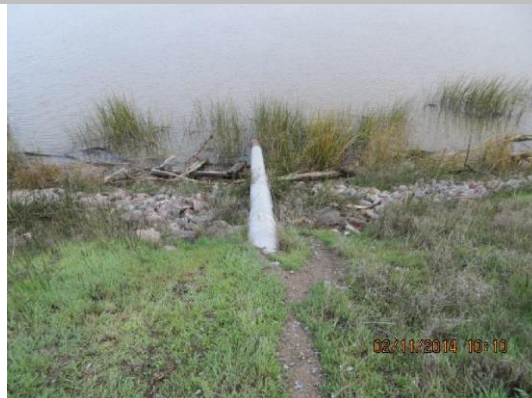
Photo 2 of 3 : UCIP_FA_2019_29187_53951.jpg

Comment Code						
Inspector Comment						
DS_ID:22202 FS_ID:29187 EP_NO: N/A Repair Type: Non-Urgent Crossing Status: Found UCIP Comments: Annular space between 12 and 14-inch pipes not grouted. FIELD_STRUCT_DESC: 14-inch steel irrigation siphon through the levee, invert elevation 2.9 feet below the crown. 14-inch pipe sleeved with a 12-inch pipe. Vent and siphon breaker on the landside (LS) shoulder. Concrete distribution box and gate valve at the LS toe. [Additional Reference(s): DWR Levee Log, 1993, referenced as a 16-inch pipe sleeved with a 12-inch pipe. USACE Sacramento O&M Manual 104, February 1960, (RM 16.92), referenced as a 16-inch pipe sleeved with a 14-inch pipe]. FS Date: 2/11/2014 11:00:22 AM

Pipe visible on WS slope.

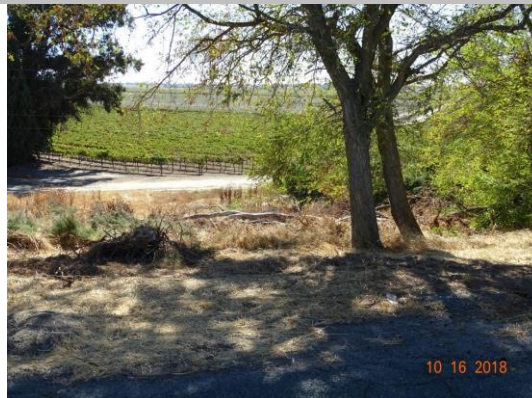
Photo 1 of 1 : FA_2019_RD0003_24_95_20190826_00077.jpg

LM Start	10.14	Rating **	M	Issue No.	95
LM End	10.14	Issue Type +	En	Location *	LS
Category	Earthen Levee			GPS Latitude/Longitude	
				Start	End
Item	Encroachments			38.188424 °	38.188424 °
				-121.641517 °	-121.641517 °
DWR ID	DWR_RD0003_01_s_2018_95				
Comment Code					
TR : Tree or limb					
Inspector Comment					
Remove tree limbs from the landside slope.

View of tree limbs on landside slope (October 2018).
